# Exhibit B

### **Executive Summary**

IDS Group, Inc. (IDS) has completed the Tier 1 seismic screening portion of the seismic evaluation study for the Fairview Development Center Acute Infirm Wards D, E, and F buildings in Costa Mesa, California. The ASCE 41-17 Standard has been used for this project. These building are classified as Risk Category II. Level of Seismicity is "High". The performance objective selected as per the standard is the Basic Performance Objective for Existing Buildings (BPOE).

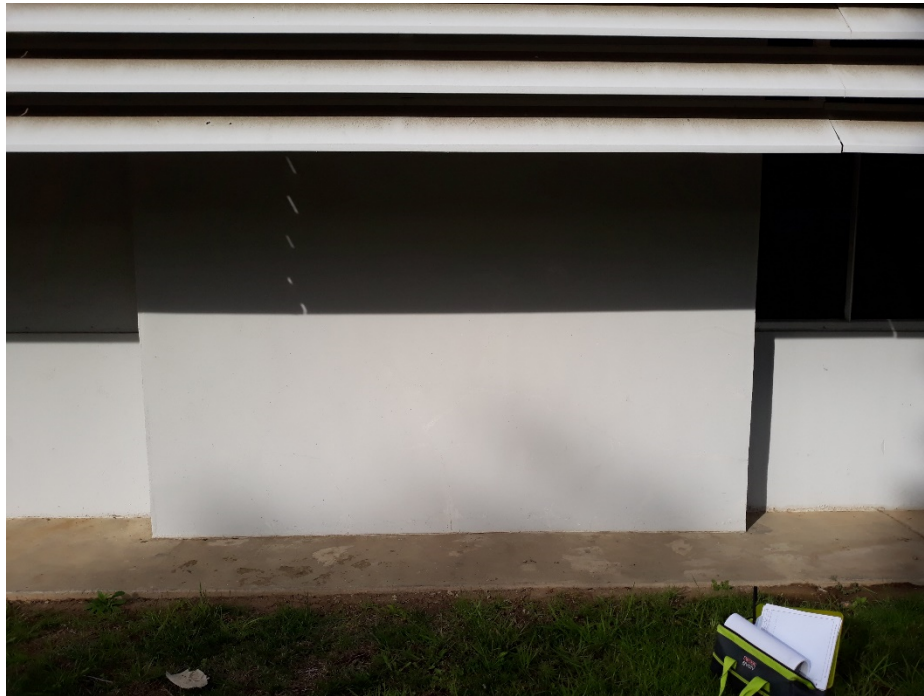
the south and north wings of the buildings were recently added. These walls were measured to be approximately 10' long and 13" thick. Figure 2 is a photograph of one of these added walls. The structural drawings of the upgrade that included addition of these walls were not available for review.

**Figure 2: Recently added concrete shear walls at the exterior of the buildings**

The apparently recent seismic upgrade of these buildings included the addition of new concrete shear walls and therefore these buildings are designated “Benchmark” buildings per ASCE 41-17. While no drawings pertaining to the seismic upgrade were available, IDS has based this conclusion upon field observed evidence of the recent upgrade, as well as verification (in person, verbal) by the facilities manager. Therefore, these buildings are deemed to comply with the basic safety objective (BPOE, structural only) of the ASCE 41-17 standard and no structural retrofit is recommended at this point in time.
